July 1979

Bulletin Number 31

AN ANALYSIS OF LANDSLIDE DAMAGE AND SLOPE STABILIZATION

NEAR SEOUL, KOREA

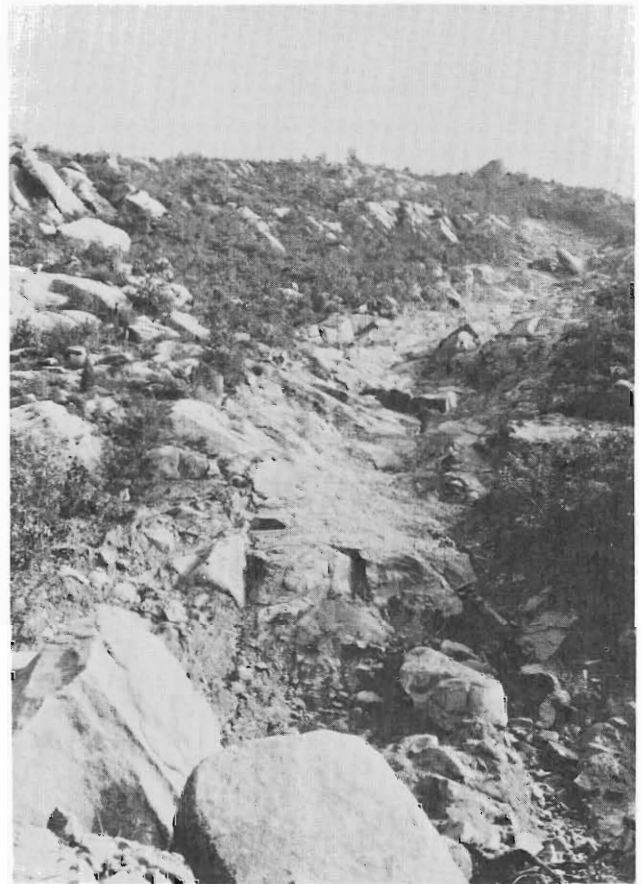
Figure 2. Landslide damage in the upper portion of the Samseong-Cheon drainage. More than 40 similar landslides occurred in this drainage.

earlier erosion. Slopes range from 50 to more than 100 percent. Stream channels are well incised, and evidence of earlier and continued mass wasting is evident. One of the more than 40 landslides observed in the drainage is shown in Figure 2. Terraces, buttressed by dry masonry walls, are being built to stabilize these slide areas.

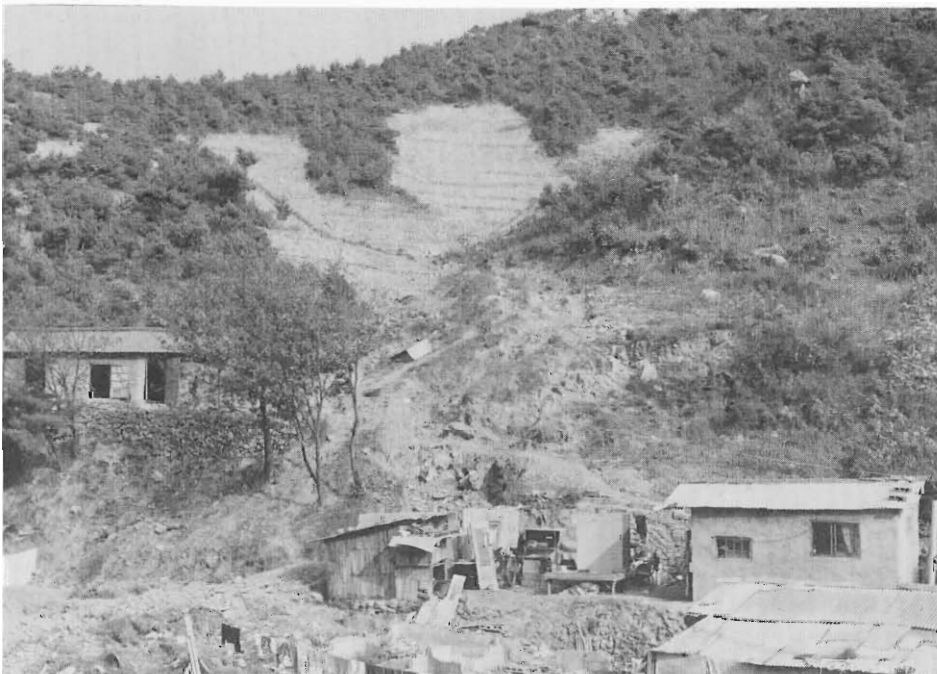
Figure 3. Debris from this slide in the Suam-Cheon drainage killed three people living in a home which was located between the two shown.

Land use in the 930-ha Suam-Cheon drainage is dominantly agricultural; however, an active quarry and a hardboard plant are found at the lower end. The dominant geological formations are augen gneiss and muscovite schist. These highly fractured formations are overlain by 20 to 100 cm of gravelly-sandy loam. Steep slopes range from 40 to 90 percent. Vegetative cover is well below natural levels due to heavy use during and after the Korean war. Evidence of past slope instability is plentiful. A debris avalanche responsible for the deaths of several people during the July 1977 storm is shown in Figure 3. Stabilization efforts such as the rock-lined channels and grade reduction structures shown in Figure 4 and terraces shown in Figure 5 have been constructed in the Suam-Cheon watershed.

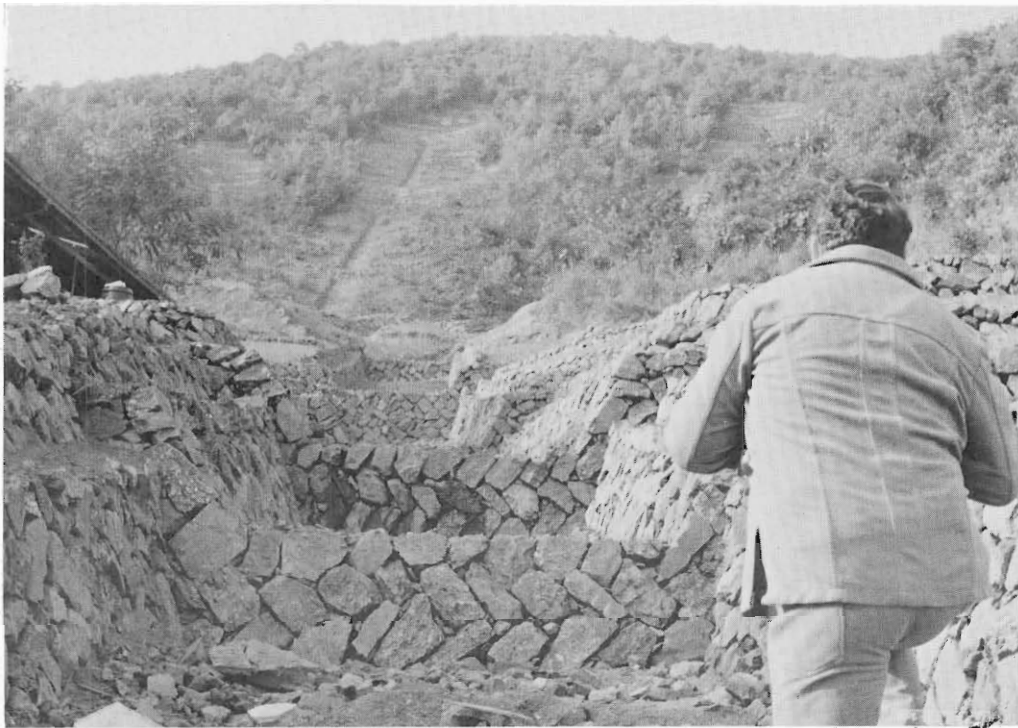
Figure 4. A stone-lined drainage channel has been installed in this slide area. Note walled steps, which reduce the effective channel gradient.
